山形月山地区におけるSAR干渉画像を用いた 地すべり性地表変動の検出

Landslides-movement detection using SAR
interferometry image in Gassan area, Yamagata Prefecture

国土地理院 *新庄河川事務所

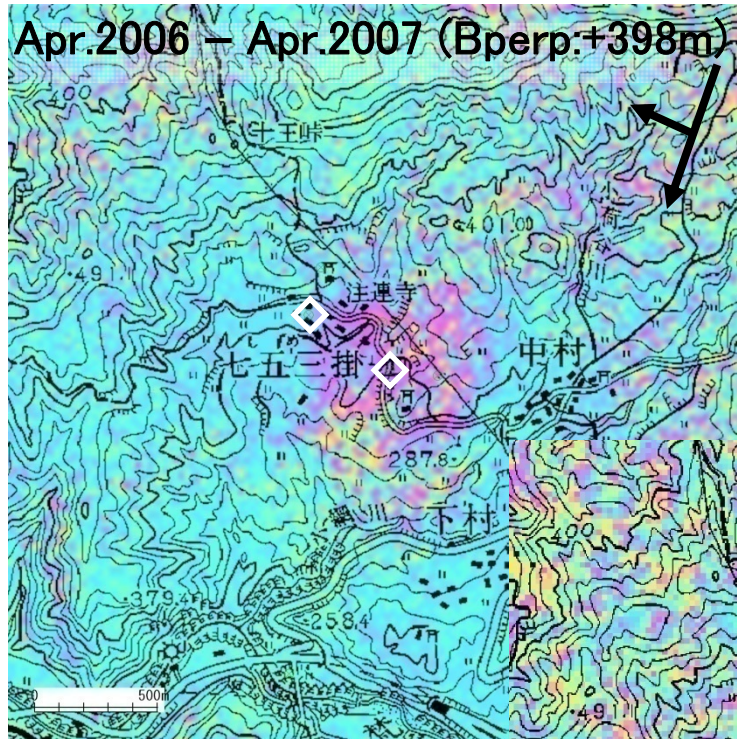
Apr.2006 – Apr.2007 (Bperp:+398m)

- Subtle land deformation before the activated landslide since Feb 2009 was detected using the two SAR interferometry images (Apr 2006-Apr 2007; Sep 2006-Sep 2008).
- Shimekake area has been damaged since Feb 2009 by the activated landslide, that may be related with the landslide movement detected by the two SAR interferometry images (Apr 2006-Apr 2007; Sep 2006-Sep 2008).

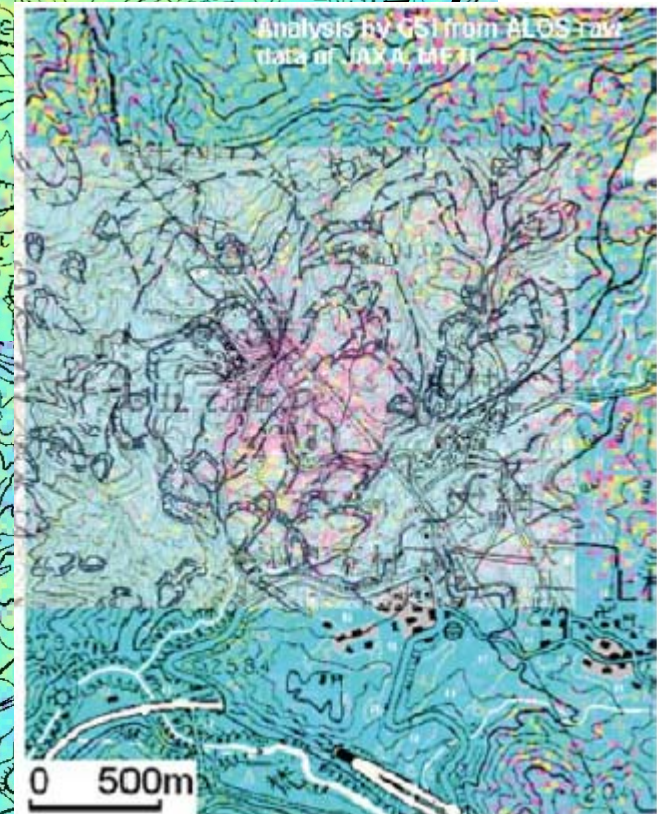
Sep.2006 – Sep.2008 (Bperp:+104m)

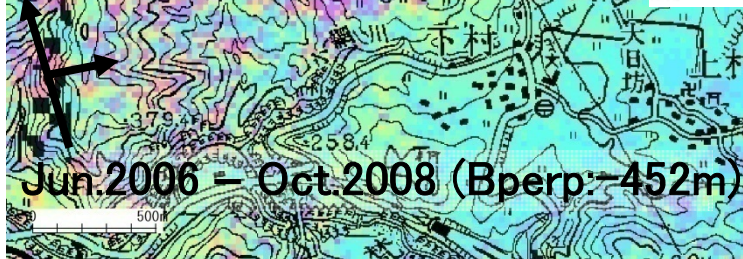
Jun.2006 – Oct.2008 (Bperp:-452m)

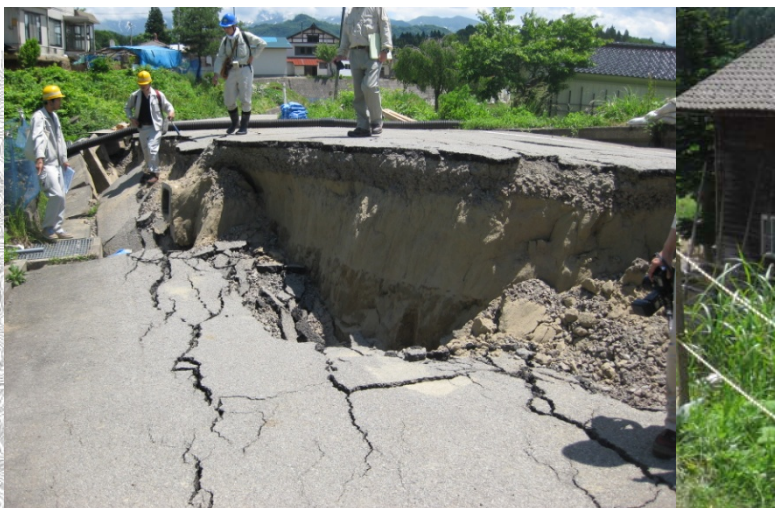
2. GPS Monitoring (Mar. 2009~)

2009/5/1	-23	-13	26	2009/7/17	10	20	22
合計	-138	-88	164	2009/7/24	-10	0	10

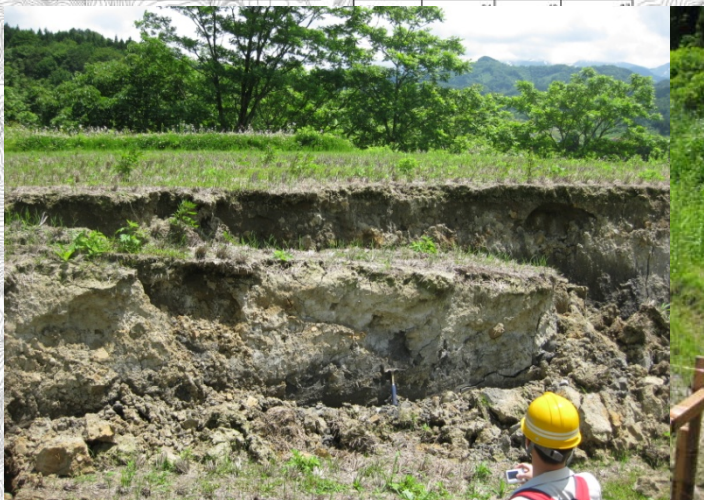
2009/6/12	0	0	0
2009/6/19	-1	1	1
2009/6/26	-9	-5	16
2009/7/3	0	-5	5
2009/7/10	-1	-3	3
2009/7/17	-6	7	9
2009/7/24	0	1	1
合計	-17	-4	17

H21. 3. 27~5. 1
の移動量1141mm
6.12亡失確認

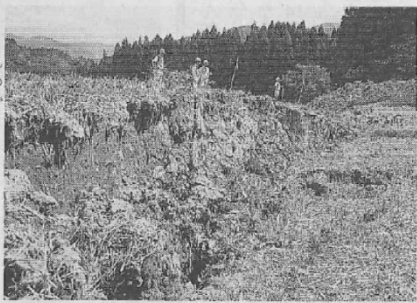
地滑りで亀裂が広がった田んぼ
＝山形県鶴岡市大網、川原写す

山形県鶴岡市大網の七五三掛地区で4月以降、地滑りによる被害が拡大している。田んぼや道路のあちこちに亀裂が広がり、最大で2層を越す段差も。家屋にも損傷が出ており、5世帯が市営住宅などに避難した。地区は水アカデミー賞を受賞した映画「おくりびと」のロケ地の一つ。地滑りの範囲は現在、幅400m、長さ700mほど面積は約28ha。同地区は農林水産省が91年に地滑り防止区域に指定し、地下水を抜く井戸を掘るなど対策を取ってきた。今回の地滑りは、住民が2月に道路の亀裂を発見。県が対策工事をしたが、4月9日に警戒水準を越す亀裂の拡大（1時間あたり2cm以上）が確認され、住民に自主避難を要請した。

29日に現地調査した国土交通省と農水省の専門家によると、深さ約24・5mの地点に「すべり面」があり、雪解け水がこの面にしみ込んで地滑りを引き起こしたらしい。調査を委託された独立行政法人土木研究所・地すべりチームの藤沢和範・上席研究員は「これから梅雨に入り、また水がしみこむので動きはしばらく止まらないだろう」と話した。

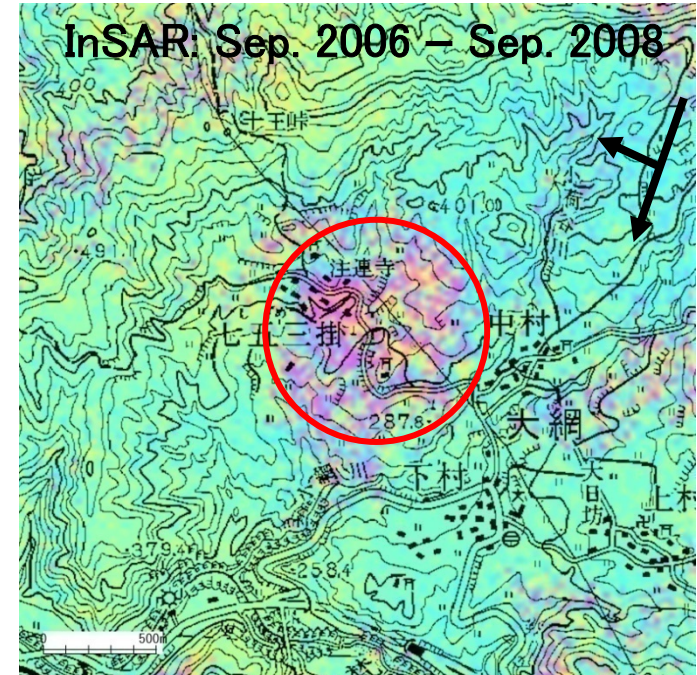
4. Model of Landslide-movement

- Landslide where the deformation was detected by InSAR
- ↓ Movement including west component, induced by snowmelt and precipitation
- Notable activated landslide since Feb 2009, that gave the damage in Shimekake area.

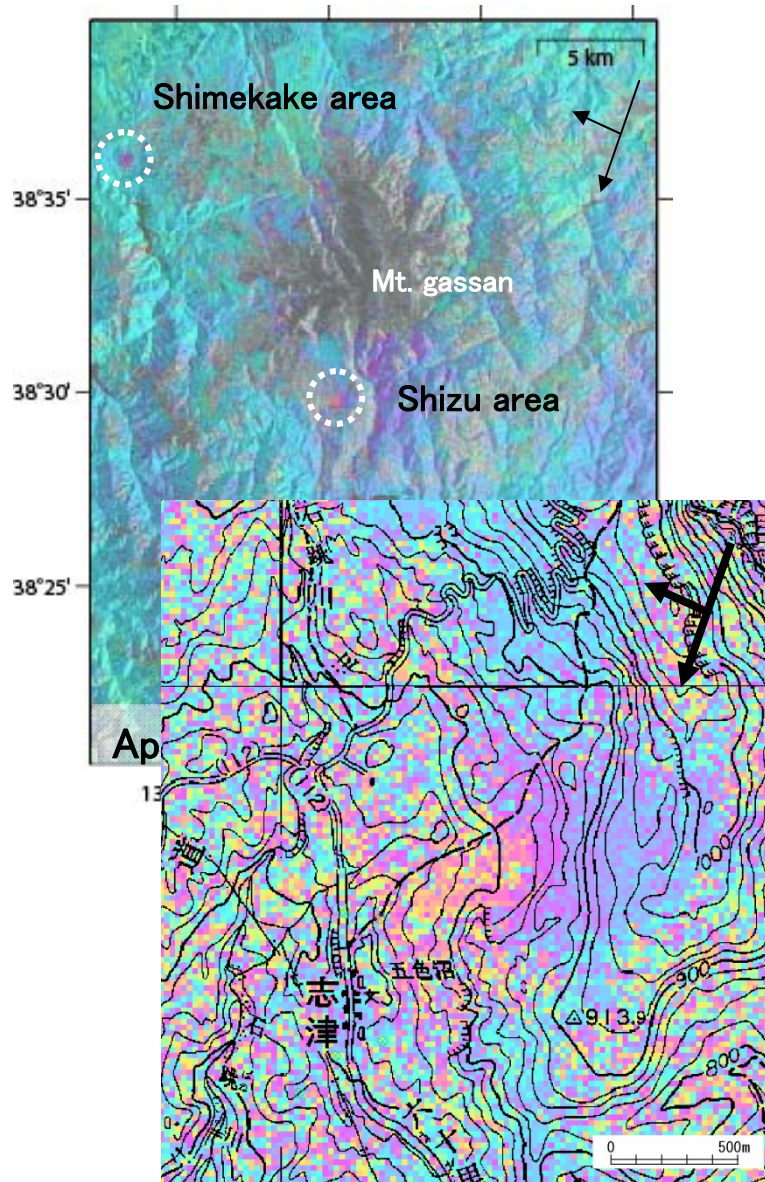
◇ GPS period: Oct. 2006 - Oct. 2008

○ GPS period: Dec. 2007 - Oct. 2008

- Deformation in landslide was detected between Apr 2006 and Sep 2008 (for more than 2 yrs), using SAR interferometry.
- Remarkable deformation was not detected between Jun 2009 and Jul 2009 (for the short period of 46 days).

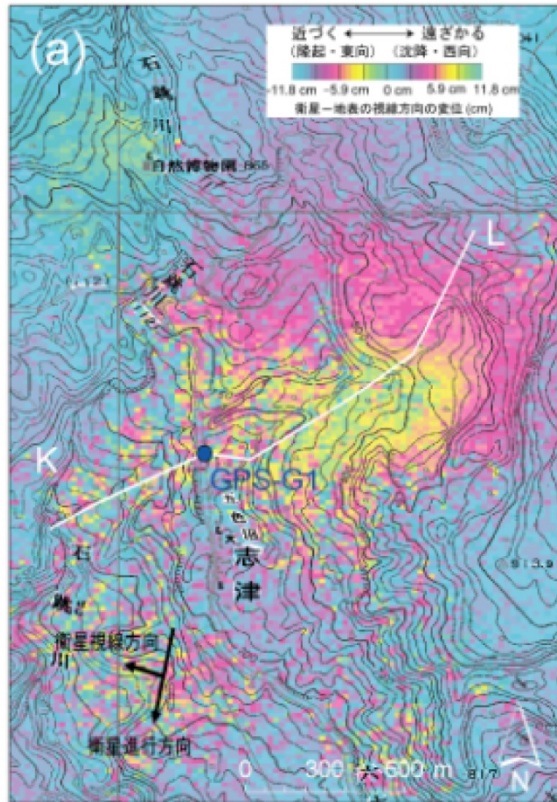
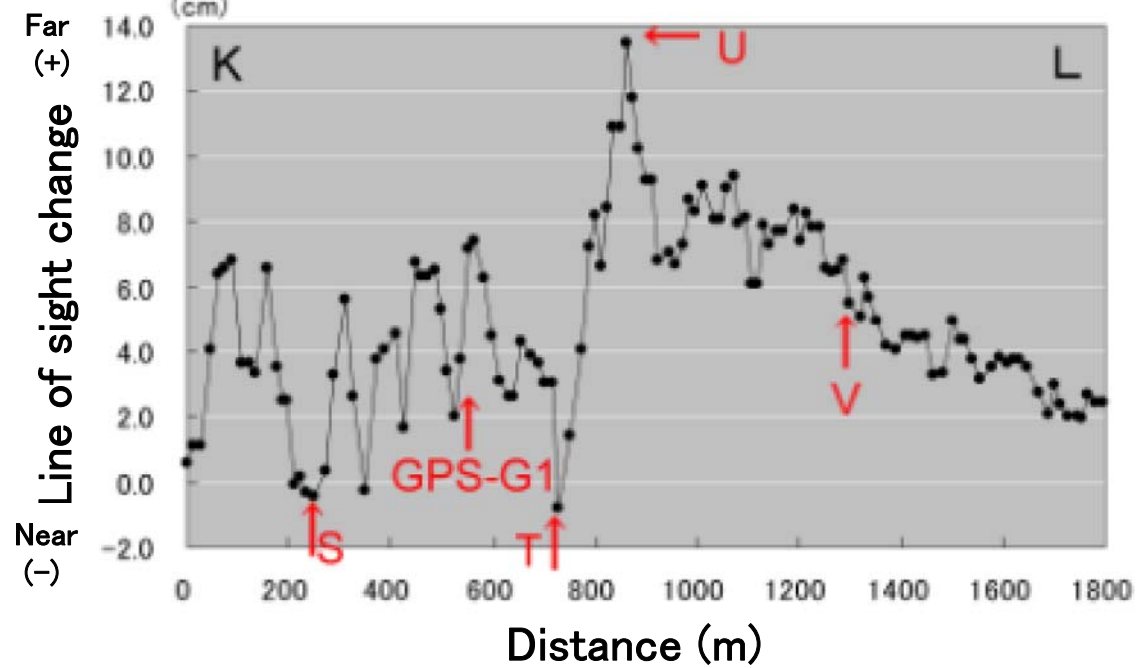
Profile of Shizu area for Sep.2006 – Sep.2008

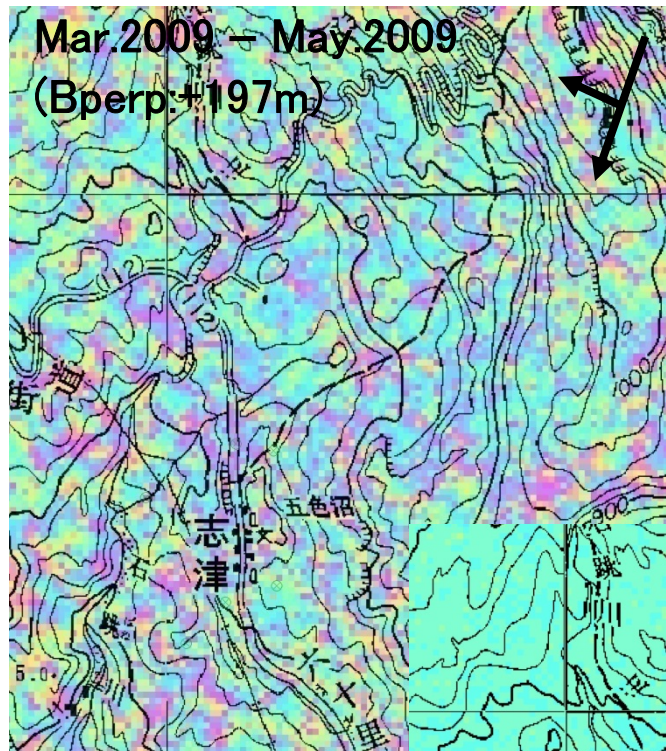
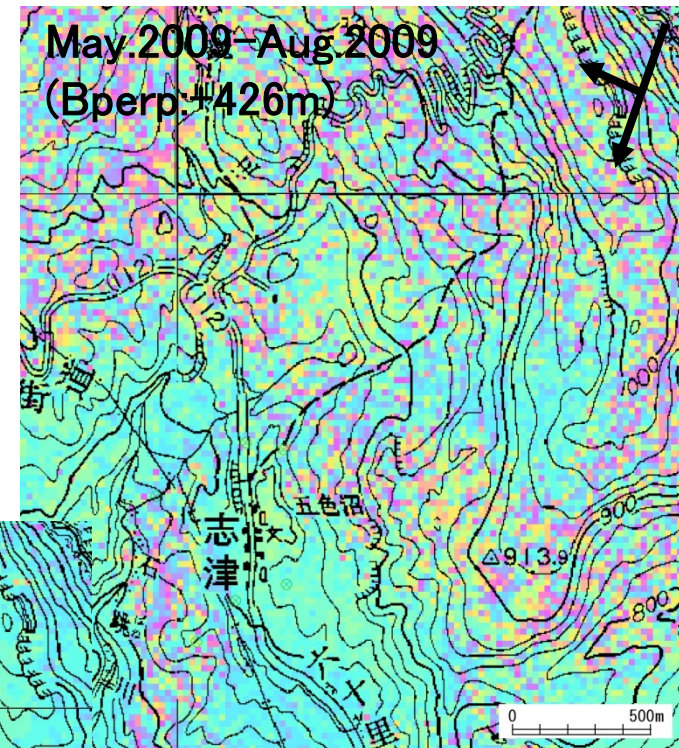
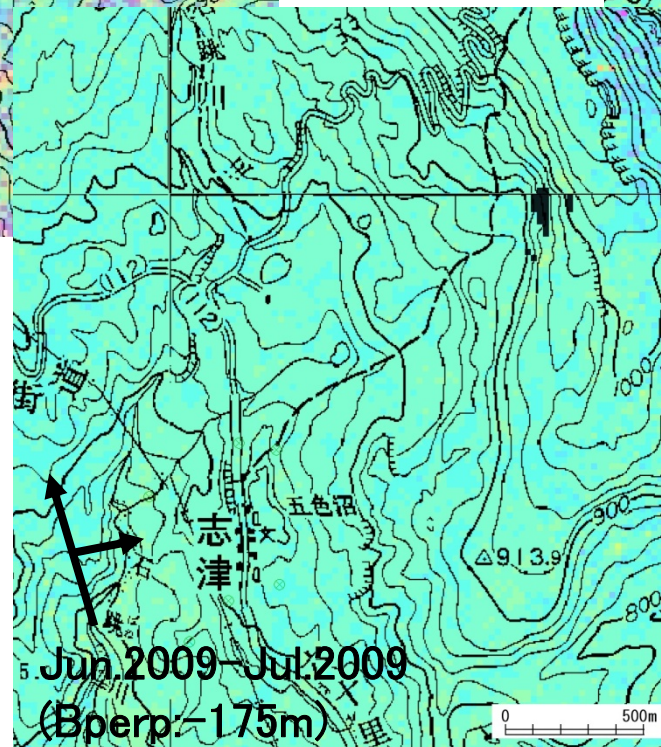
Landslide movement of Shizu area after Mar. 2009
